BABBIDGE RESERVOIR DAM

NH 00398  
NHWRB 206.03

PHASE I INSPECTION REPORT  
NATIONAL DAM INSPECTION PROGRAM

AUGUST 1981

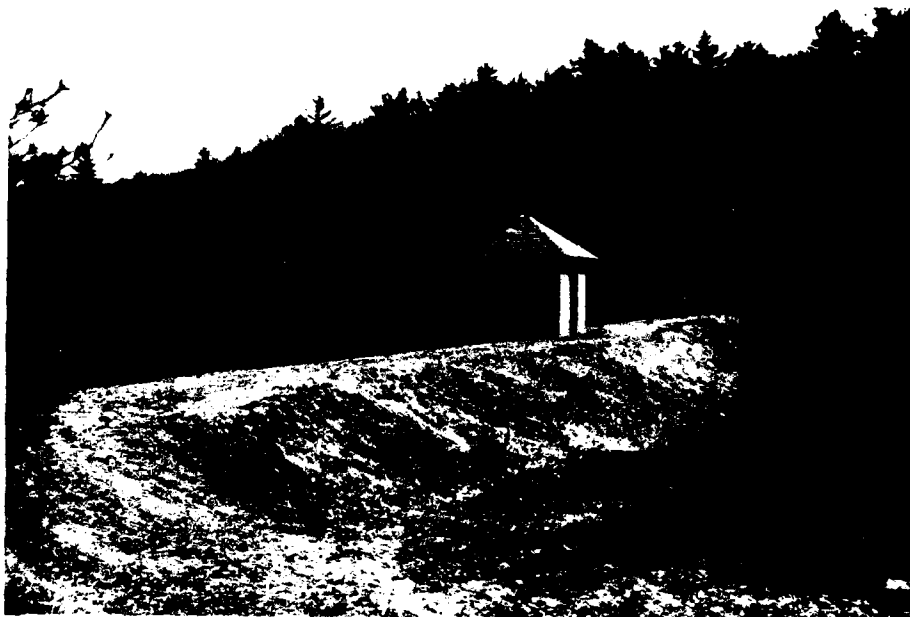
The alignment of the dam along the crest is generally good to slightly irregular. The irregularity consists of a vertical depression near the gatehouse which is visible in Photo No. 1. This depression is due to the manner of construction and is not attributed to movement of the crest. The riprap on the upstream slope is generally in good condition, although there is brush growing through the riprap.

1. Overview of Downstream Slope From  
Left Abutment
